**Australian Standard 5113**  
**Fire Propagation Testing and**  
**classification of external walls of**  
**buildings**

**QT Panel with 10mm Cement**  
**Render**

IGNL-3282-08 I01 R01

Tested: 04.12.2019  
Issued: 18.01.2020

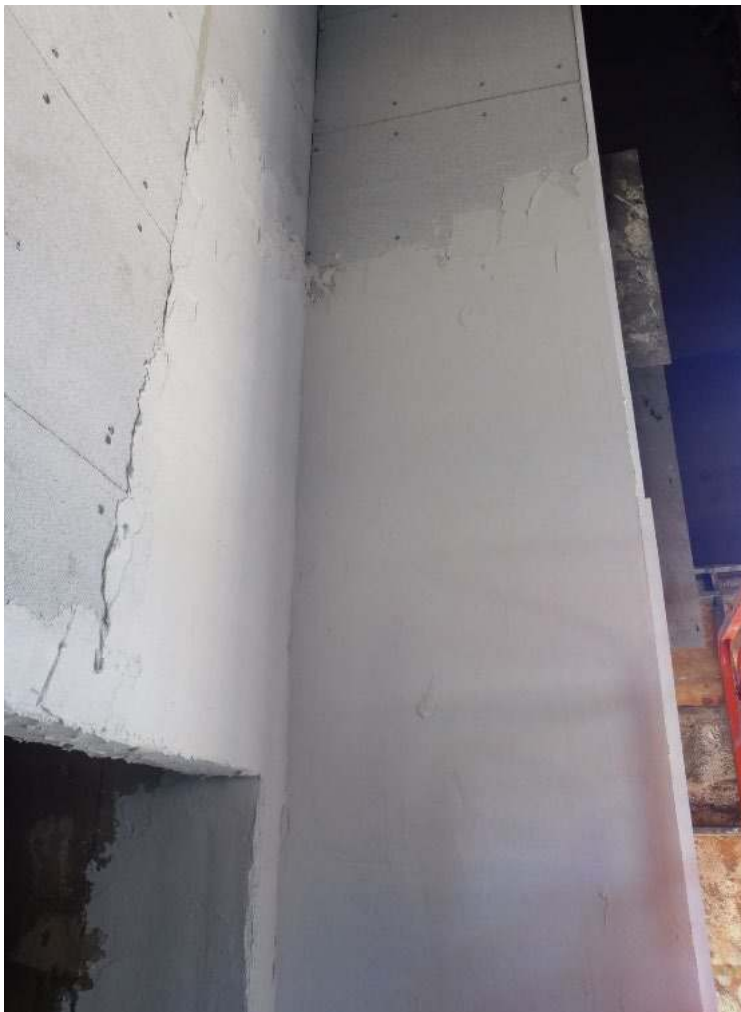
FIGURE 6:  
CEMENT RENDER INSTALLATION

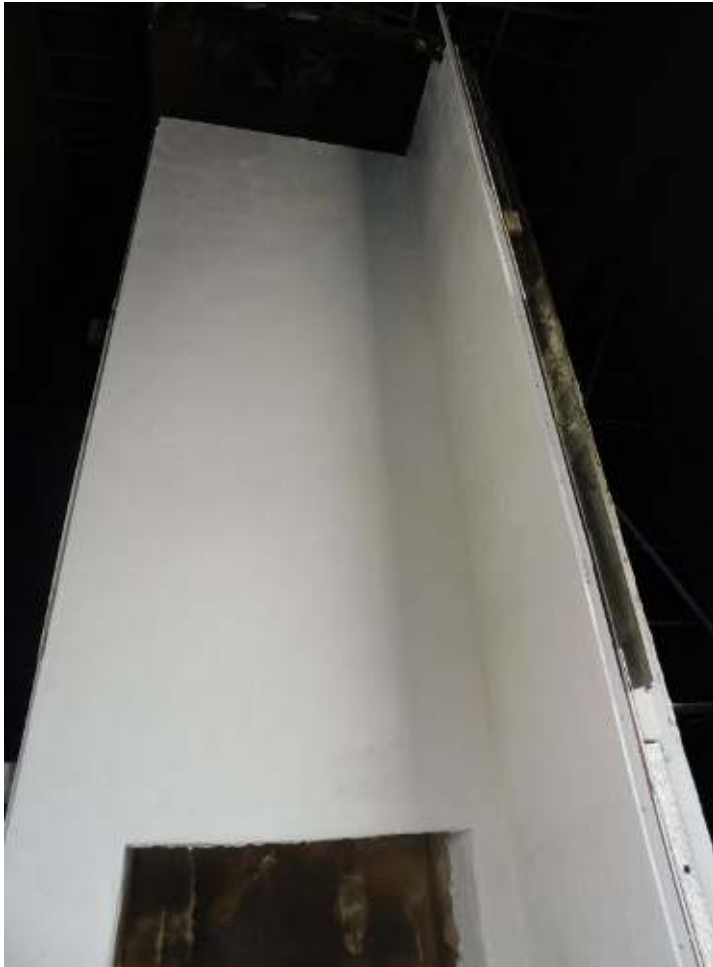
FIGURE 7:

## CEMENT RENDER INSTALLATION

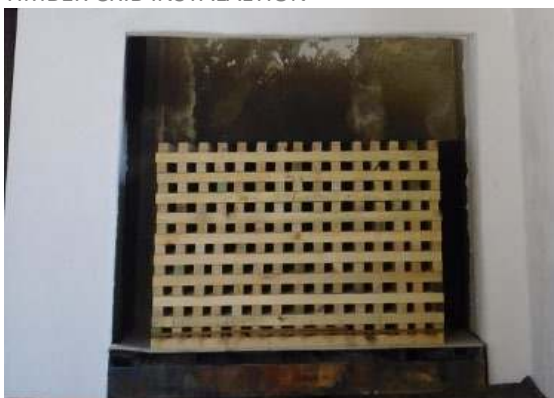
FIGURE 8:

The timber crib included 1500-mm wide, 1000-mm deep and 1000-mm high of pinus radiata being in the order of 50 mm square section. The crib was located centrally within 250mm of each side and within 100mm to the front and rear of the crib platform. Each crib timber element was measured with a J-2000 Delmhorst moisture meter where the moisture content was 10.1%. The following image details the timber crib installation.

## TIMBER CRIB INSTALALTION

The crib platform was located on a plinth comprising a single layer of 16mm CSR Fyrecheck and a steel sub-frame to a height of 410mm for the test.

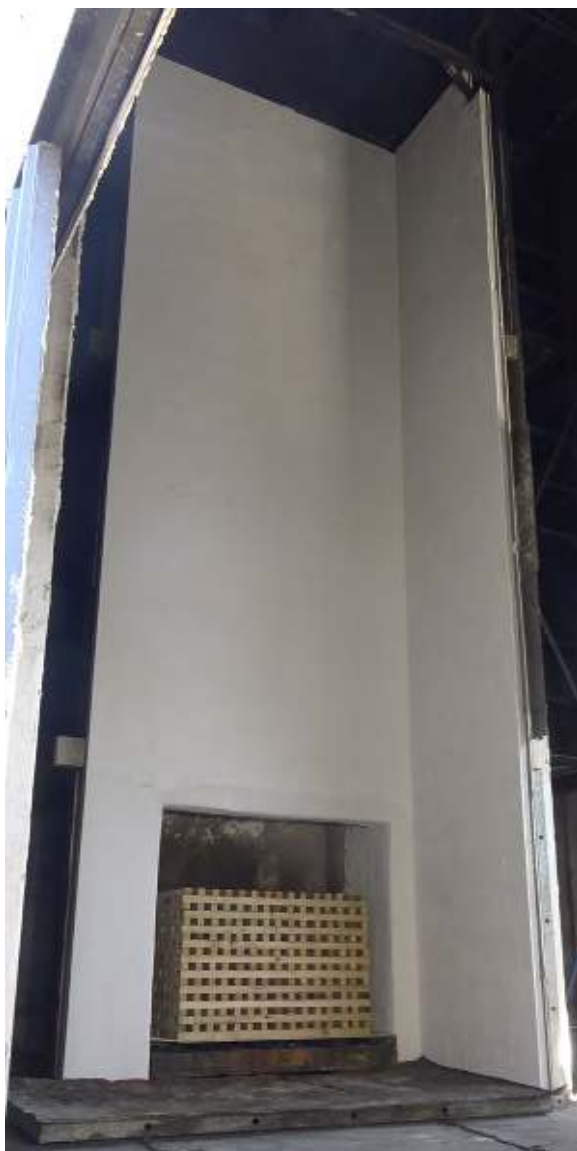
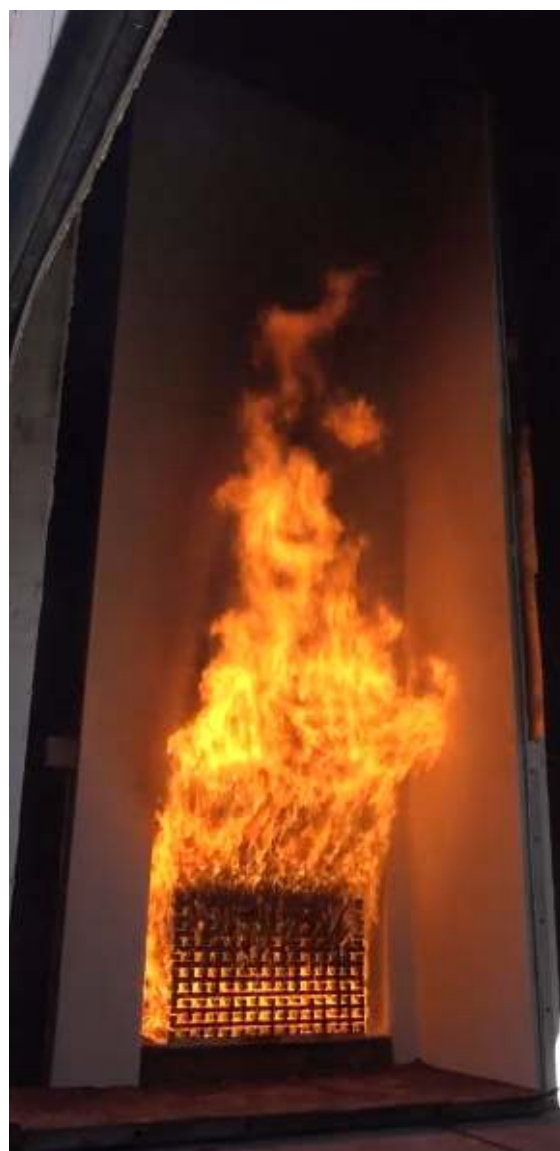
FIGURE 16:

START AND 10 MINUTES

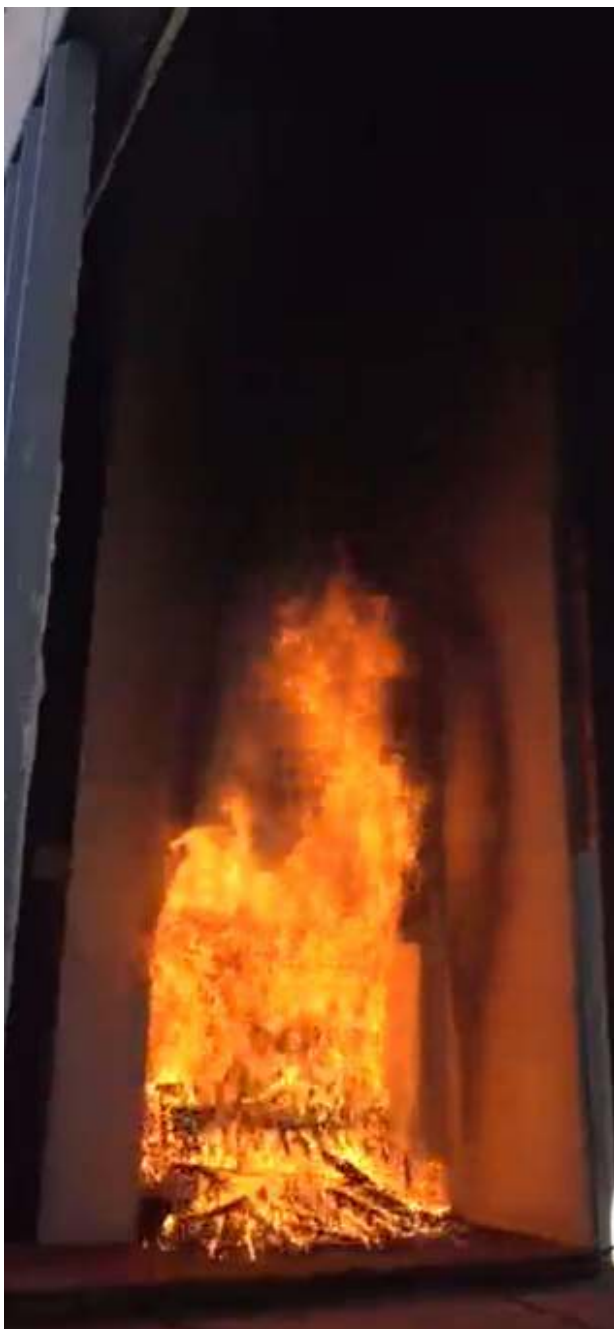
FIGURE 17:  
CRIB COLLAPSE AND 30 MINUTES
